**DEPARTMENT OF TRANSPORTATION**

Contract #: 04-0120F4Cty: SF/ALA Rte: 80 PM: 13.2/13.9File #: 1.28**WELDING INSPECTION REPORT****Resident Engineer:** Siegenthaler, Peter**Address:** 333 Burma Road**City:** Oakland, CA 94607**Report No:** WIR-017103**Date Inspected:** 30-Sep-2010**Project Name:** SAS Superstructure**OSM Arrival Time:** 1000**Prime Contractor:** American Bridge/Fluor Enterprises, a JV**OSM Departure Time:** 1830**Contractor:** American Bridge/Fluor Enterprises, a JV**Location:** Job Site**CWI Name:** See Below**CWI Present:** Yes No**Inspected CWI report:** Yes No N/A**Rod Oven in Use:** Yes No N/A**Electrode to specification:** Yes No N/A**Weld Procedures Followed:** Yes No N/A**Qualified Welders:** Yes No N/A**Verified Joint Fit-up:** Yes No N/A**Approved Drawings:** Yes No N/A**Approved WPS:** Yes No N/A**Delayed / Cancelled:** Yes No N/A**Bridge No:** 34-0006**Component:** Orthotropic Box Girders**Summary of Items Observed:**

## WELDING INSPECTION REPORT

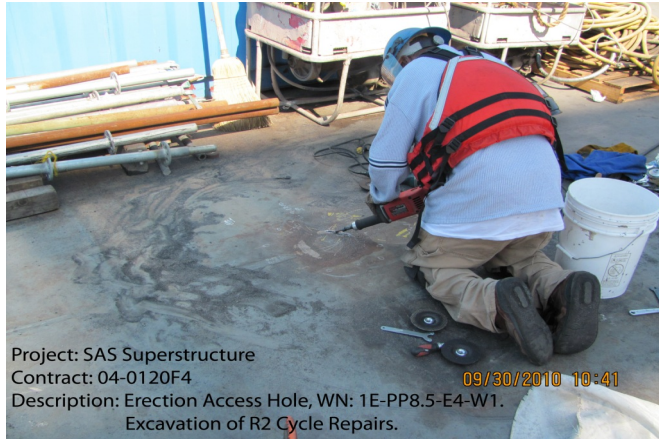
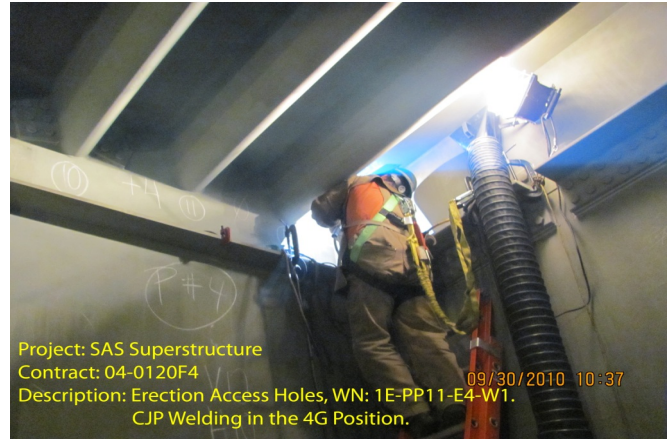
The digital photographs on page 4 of this report illustrate the work observed during this scheduled shift.
